# Performance Optimization of a Rotor Alone Nacelle for Acoustic Fan Testing

C.C. Cunningham, W.K. Thompson, and C.E. Hughes  
Glenn Research Center, Cleveland, Ohio

Prepared for the  
39th Aerospace Sciences Meeting and Exhibit  
sponsored by the American Institute of Aeronautics and Astronautics  
Reno, Nevada, January 8–11, 2001

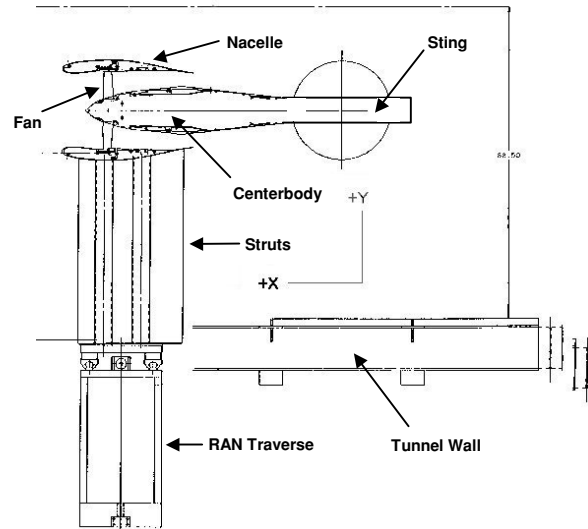
Fig. 1. Top View of RAN System in 9'x15' LSWT

supported by two struts that attached to a 2-axis traverse table positioned outside the test section flow behind the tunnel walls (Figs. 1 & 2).

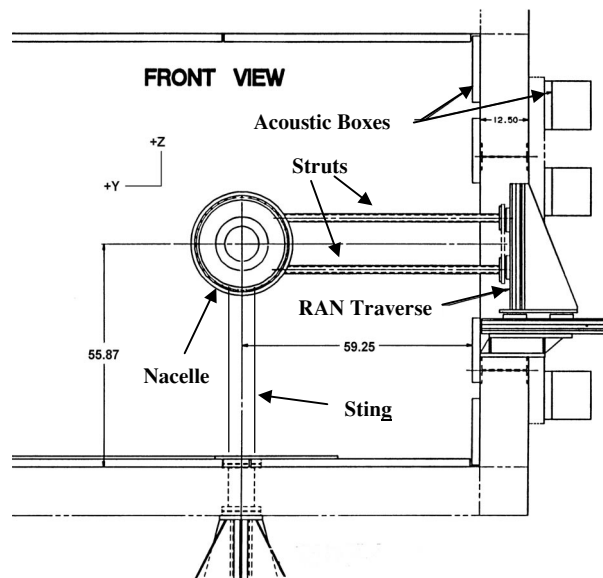
Fig. 2. Front View of RAN System in 9'x15' LSWT

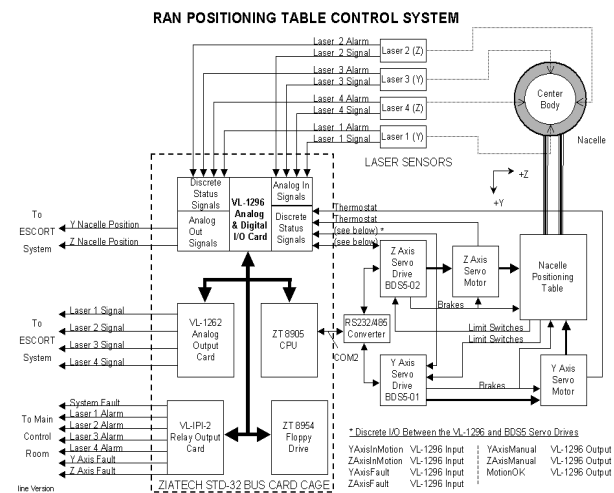
Fig. 3. RAN Hardware Schematic

carbon steel. Two servomotors (Kollmorgen Industrial Drives, model B-102-A-23) moved the table through two 100:1 gearboxes. Four nacelle-mounted laser displacement sensors measured the concentricity error, and a PC-based control system commanded the servomotors to move accordingly (Fig. 3). In addition to numerous software and hardware travel limits to maximize system safety, a 3/4" highly abrasive rub strip was incorporated into the nacelle to minimize any chance of damage to the fan blades during an incursion.

Position feedback came from the four laser displacement sensors (Micro Laser Sensor model LM10) located at 90-degree intervals around the center body. For RAN, two lasers actively were to provide positional data on the rotational plane (Y & Z), while the remaining two were to act as backups. Due to space constraints, the lasers could not be mounted with the beam directed radially; consequently, both the source and scatter signals were deflected 90° via polished aluminum plates. Bench tests confirmed the validity of this approach. The targets, which were 1" diameter flats machined on the centerbody, were located approximately 6.3" from their respective mirror. The laser configuration is shown in Fig. 4. The analog signals from the sensors were fed into a VersaLogic VL-1296 multi-purpose I/O card, as were the discrete signals for each laser sensor alarm, motor thermostats, axis faults and axis motion indicators. Discrete outputs from this card enabled motion and placed the servodrives in manual or automatic mode.

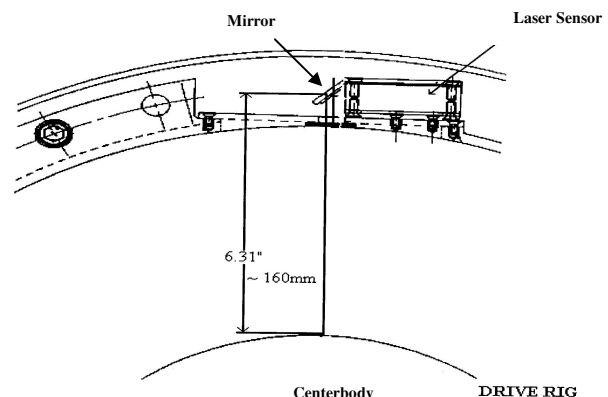
Fig. 4. Side View of Displacement Sensor

The lasers were raised about 1/8" off the casing, and nitrogen at ambient temperature was injected between the shield and the bottom of the unit. A sheet metal housing enclosed each laser and allowed the cooling gas to engulf the unit prior to discharge into the tunnel. Thermocouples with a  $\pm 1.0^\circ\text{F}$  relative uncertainty were attached to the side of each laser unit (the location where enclosure temperatures were anticipated to be the highest) opposite from the nitrogen cooling tubes. Cooling pressure, laser temperature, nacelle excitation, and RAN position were monitored from an auxiliary control room.

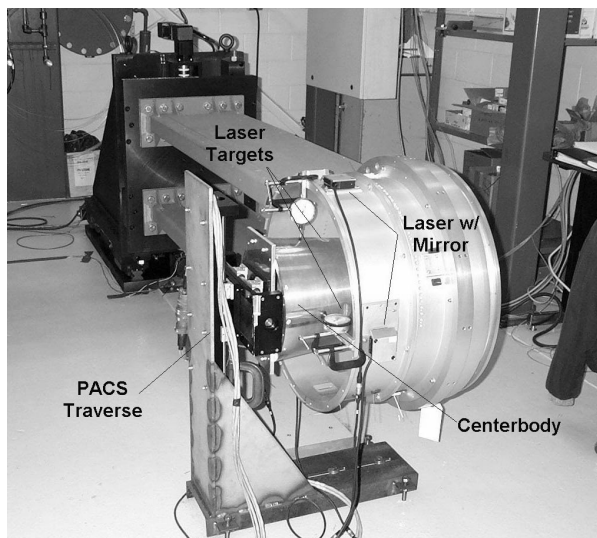
Fig. 5. Checkout of RAN w/PACS Traverse

Due to the complexity of the RAN system and the safety issues involved, a comprehensive checkout of RAN was required prior to 9'x15' LSWT installation. The RAN traverse table was floor-mounted and qualified with the same hardware that would be used in the LSWT (Fig. 5). The target centerbody (w/ machined flats) was mounted to a controllable 2-axis traverse system (Probe Actuator Control System, or PACS) that provided motion to within 0.001", allowing the RAN system response to be compared against known inputs. Checks included manual and automatic operability, sampling rate, vibrational response, and failure modes. Since the main design goal of the RAN system was to prevent a fan rub into the casing, the checkout was conducted with fail-safe operation in mind. Three independent limit controls ensured that contact between the rotor tips and the metal casing beneath the rub strip would not be possible.

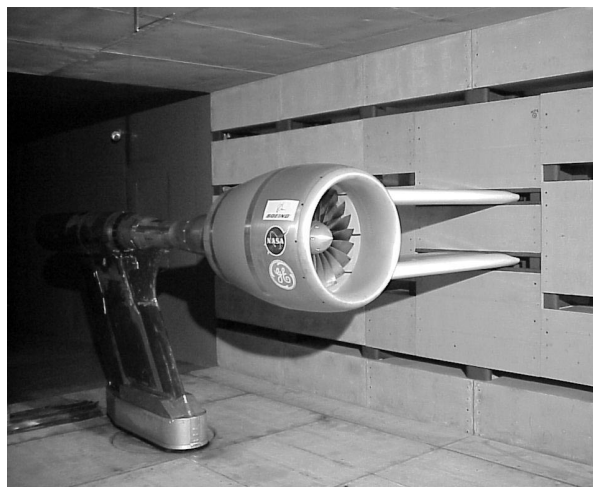
Fig. 6. RAN hardware in the 9'x15' LSWT

During a check out test of the RAN system without a fan in the LSWT, the aerodynamic effects on the system were measured. As expected, the symmetry and stiffness of the struts prevented any measurable displacements. The first test with an operating fan was focused on identifying nacelle vibration and performing basic RAN control. Although the corrected fan speed was limited to 60%, the fan did not rub, and the nacelle excitation never exceeded the noise floor. A post-run impact test confirmed that the RAN system was highly damped. Fig. 6 shows a typical test configuration.

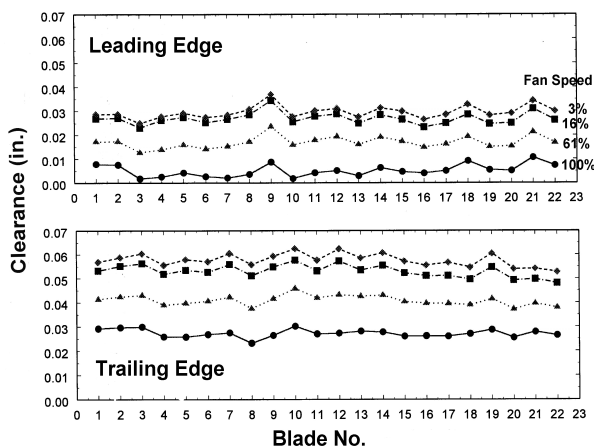
Fig. 7. Tip Clearance Results

The first test of RAN at 100% corrected fan speed (w/ 0.004" deadband) resulted in a 0.020" rub, suggesting a total rig/nacelle non-concentricity of about 0.040". A review of the displacement and temperature data showed that the laser measurements drifted more than anticipated, biasing the displacement by about 0.015". The laser cooling system, which was previously untested, would have to be significantly improved. However, these findings did not fully account for the 0.040" error in radial concentricity.

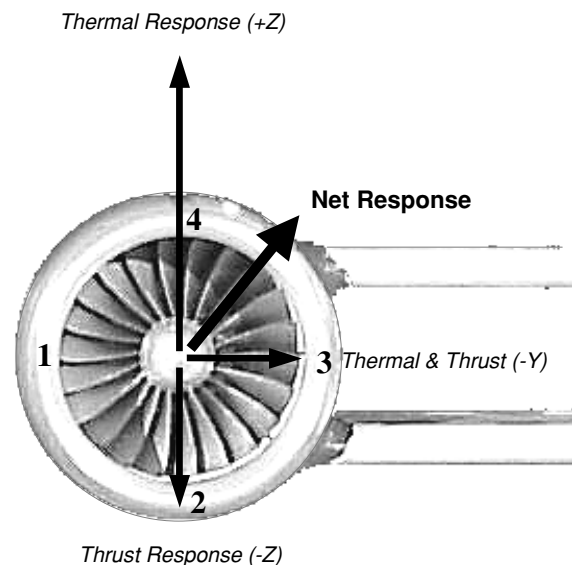
Fig. 8. Characteristic Displacement Vectors  
(w/ Lasers Numbered)

Second, the amount of error introduced by the thermal drift effect was calculated. With the exception of the unit mounted near the attachment of the strut (Laser 3, as shown in Fig. 8), each laser unit had nearly identical temperature response during testing. Because of its proximity to the nacelle/external strut attachment point, laser 3 was exposed to a larger heat source. The maximum cooling flow rate supplied to laser 3 was insufficient to reduce the enclosure temperature to the level of the other three lasers. However, since the other units stayed consistent, the net effect was similar to a common mode source of error on a differential measurement. As the nacelle temperature rose, the output readings from each laser rose by roughly the same amount. A correction factor was obtained by computing the arithmetic average of two lasers mounted directly opposite from one another on the nacelle. This average represents the common mode component due to thermal drift. By subtracting this common mode component from the control laser readings of all four lasers before computing the required table motion, the effect of the thermal drift was greatly reduced.

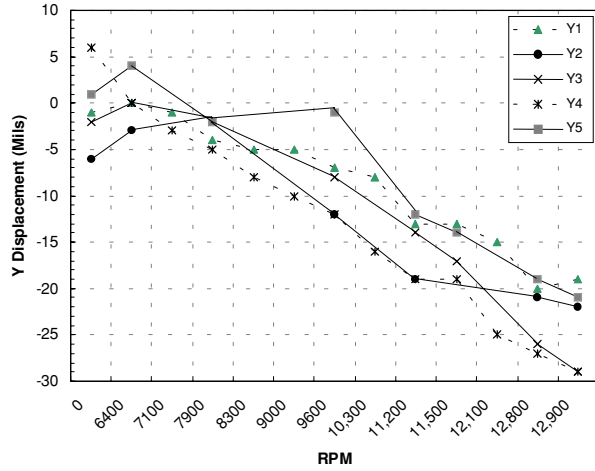
Fig. 9. Y-axis Absolute Position vs. RPM

With the system optimized, the displacement data becomes more meaningful. Prior to RAN, drive rig motion was assumed dependent primarily on rotor speed for slow ramp rates. The sample data from five runs to 100.7% corrected fan speed (Figs. 9 and 10) showed this not to be the case. It should be noted that the position data was recorded only at steady-state conditions and does not represent every move performed by the system. Displacement differences of over 0.010" and 0.030" in the Y and Z-directions, respectively, were common even on tests with identical configurations. In fact, displacement could not be directly correlated to overall ramp rate, idle time, ambient conditions, or rig modifications. Therefore, maintaining concentricity by utilizing historical displacement data in a passive control system would most likely be unsuccessful.

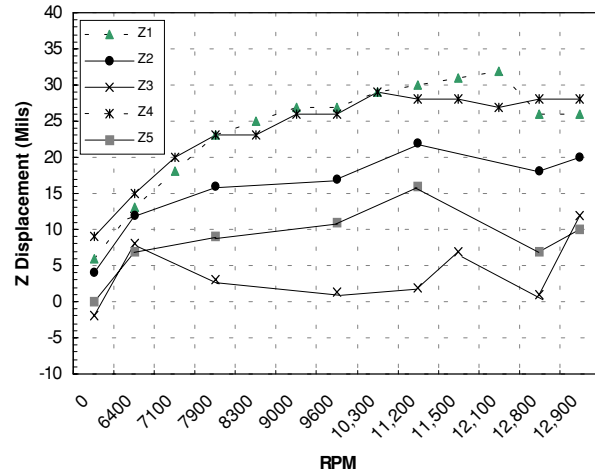
Fig. 10. Z-axis Absolute Position vs. RPM

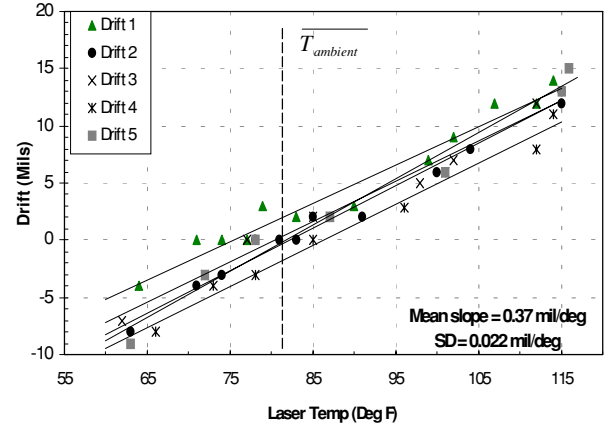
Fig. 11. Laser Drift vs. Sensor Temp

linear function of the change of laser temperature,  $\Delta T$  (0.0037"/deg). Since drift was linear and the correction was based on averaging, the residual drift could be calculated from the differences in  $\Delta T$  of opposing lasers. The residual drift was found by multiplying half of the laser temperature difference by the individual drift slope for that run (Fig. 12). In the Z-direction, the temperature rise always favored Laser 2, presumably due to local equilibrium conditions. Consequently, the offset always biased in the same direction (-Z). The slopes of the residual drift curves were very consistent, with a mean slope of 0.00020"/deg and a standard deviation of only 0.000017"/deg.

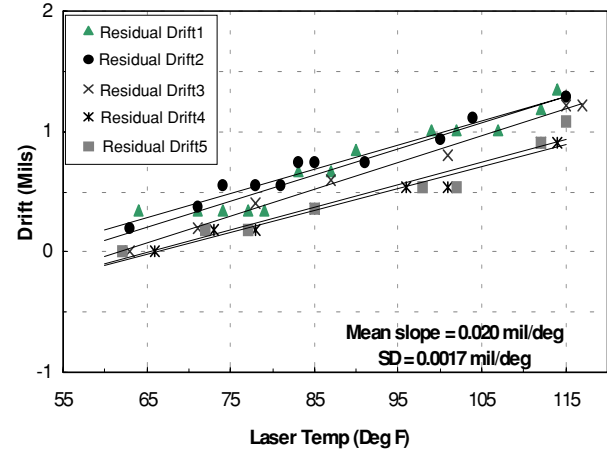
Fig. 12. Residual Drift after Correction

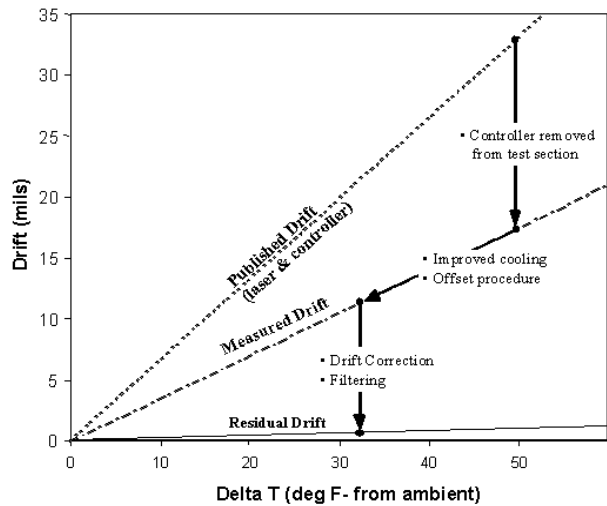
Fig. 13. Drift Reduction Chart

A summary of the data and results from the concentricity analysis can be found in Table 4. Fig. 13 shows the reduction in drift slope, along with the effects of cooling and offset. A few comments on the error sources are necessary. The quantization error was an artifact of the analog-to-digital conversion, as calculated for a 12-bit system. The values for corrected laser drift were dependent only on the accuracy of the temperature measurements. If we assume a worst case scenario, where the thermocouple error caused opposing laser temperatures to diverge by  $2.0^\circ\text{F}$ , the effect on residual drift calculation was only 10%, or about  $0.0001''$ . As for system lag, the ramp rates (and hence rig displacements) never exceeded 25 rpm/s, leading to minimal system lag. Even so, an ample lag error of  $0.0005''$  was assumed for each axis.
